PRELIMINARY INVESTIGATION OF GUY ALLOY AS A TURBOJET-  
ENGINE BUCKET MATERIAL FOR USE AT 1650° F

By R. A. Signorelli, J. R. Johnston, and J. W. Weeton

Lewis Flight Propulsion Laboratory  
Cleveland, Ohio

November 29, 1956  
Declassified January 10, 1957

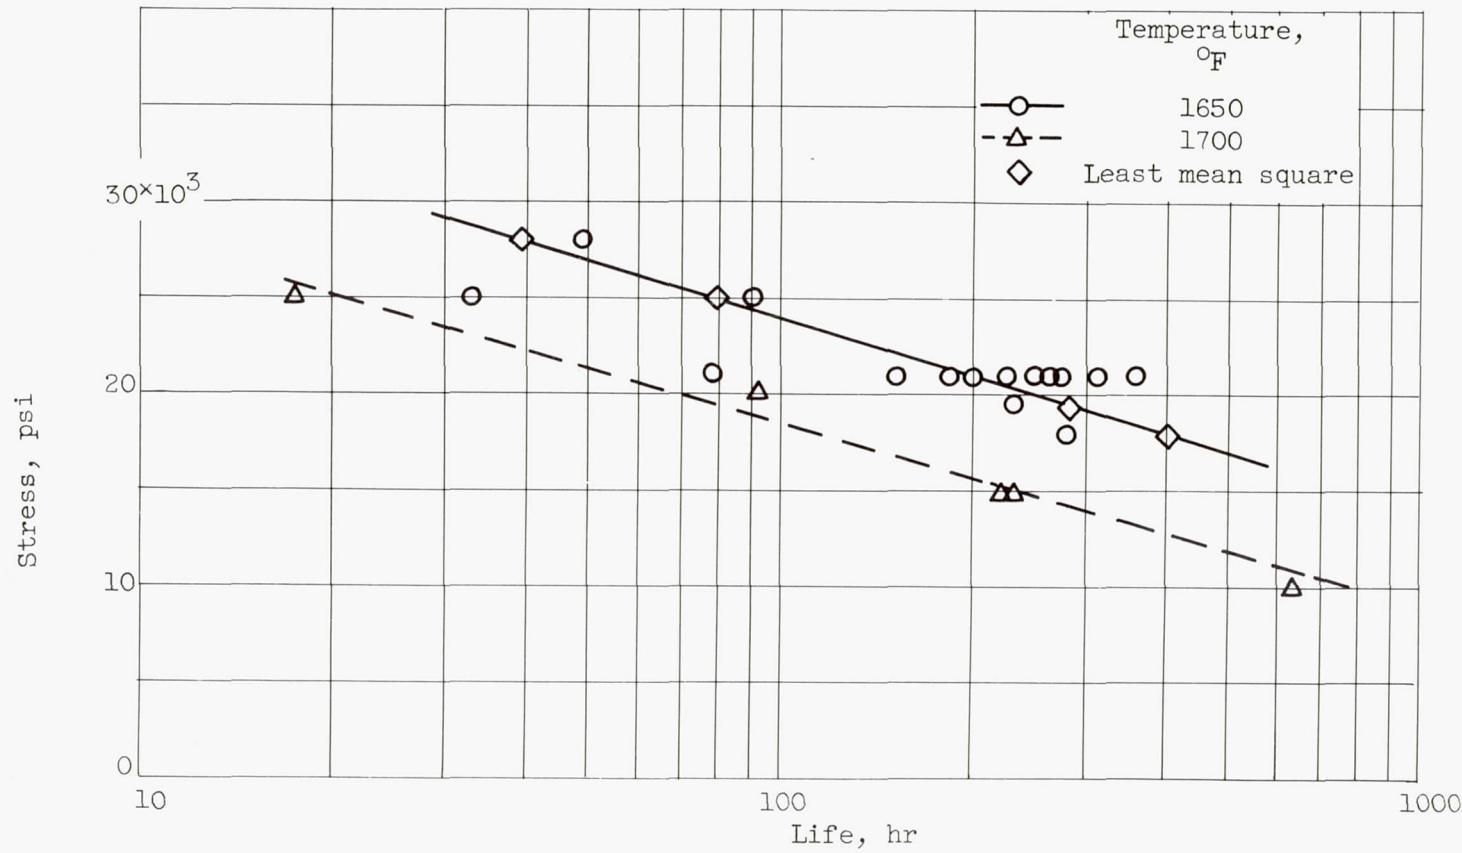
To reproduce and extend the stress-rupture data of reference 1, rupture bars were cast and evaluated. The stress-rupture results obtained (fig. 1) indicated that Guy alloy could be considered for use as a bucket alloy at bucket temperatures 150° to 200° F higher than normal operating temperatures of current engines. The low elongation values obtained in these rupture tests (3 to 6 percent at fracture) and in tensile tests at room temperature indicated limited ductility, however.

Figure 1. - Stress-rupture properties of Guy alloy cast at Lewis laboratory.

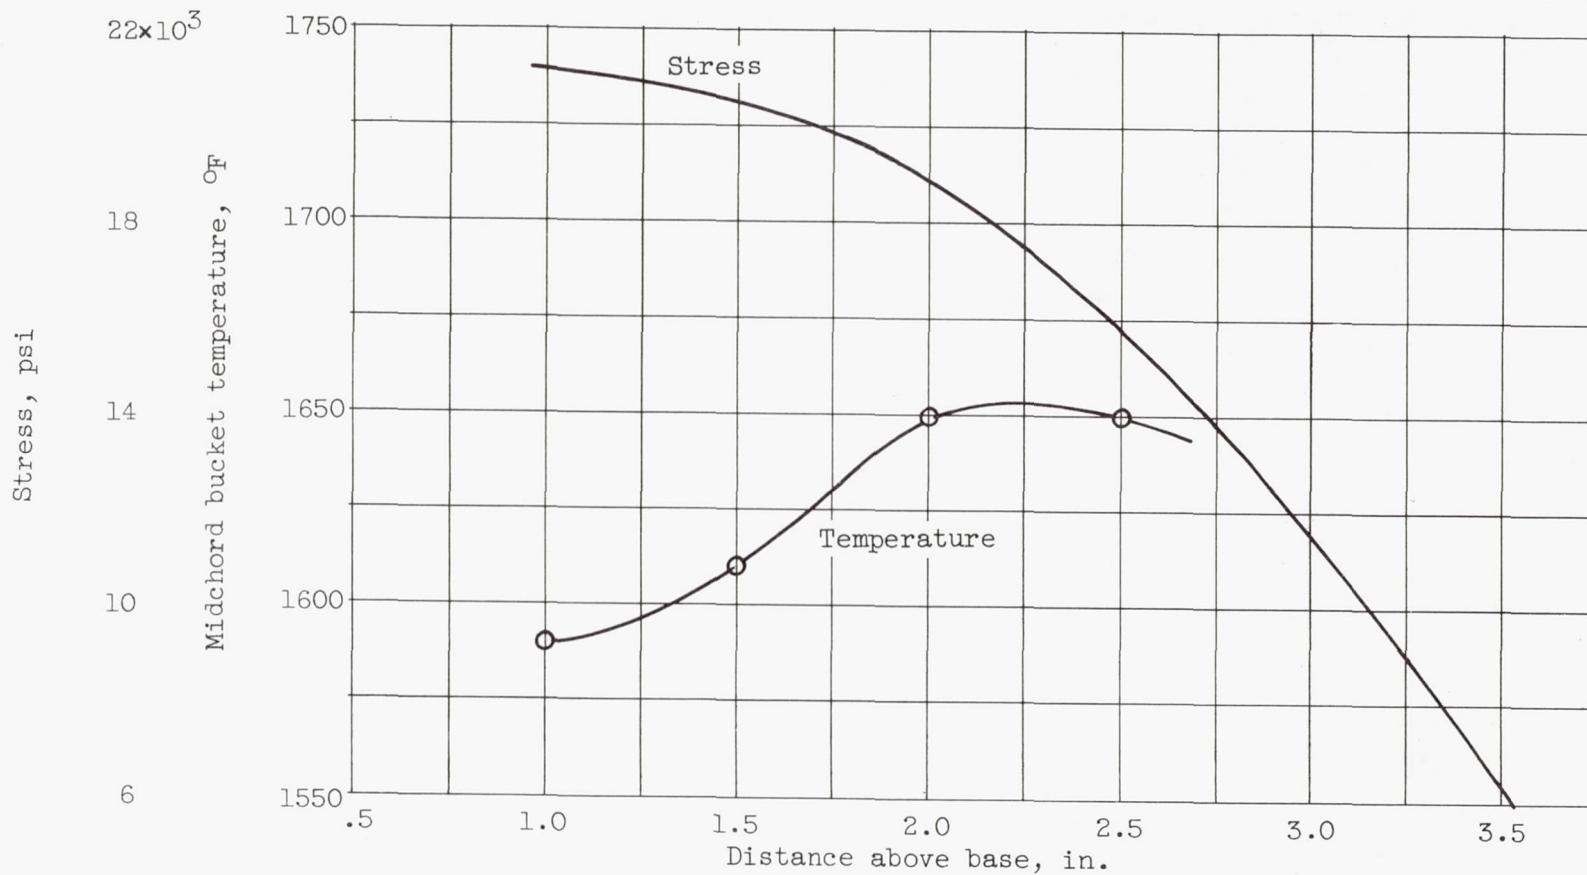
The distributions of centrifugal stresses and temperature in buckets during engine operation are shown in figure 2. The stresses in bucket airfoils were calculated using density and cross-sectional-area measurements by the method described in reference 3. To obtain the bucket temperature distribution prior to evaluating the Guy alloy buckets, a full turbine wheel of S-816 buckets was operated in the engine for a few minutes. The bucket temperature was obtained from thermocouples installed in buckets and connected to a recording device through slip rings, using the method described in reference 4.

Figure 2. - Distribution of centrifugal stress and temperature in Guy alloy buckets.

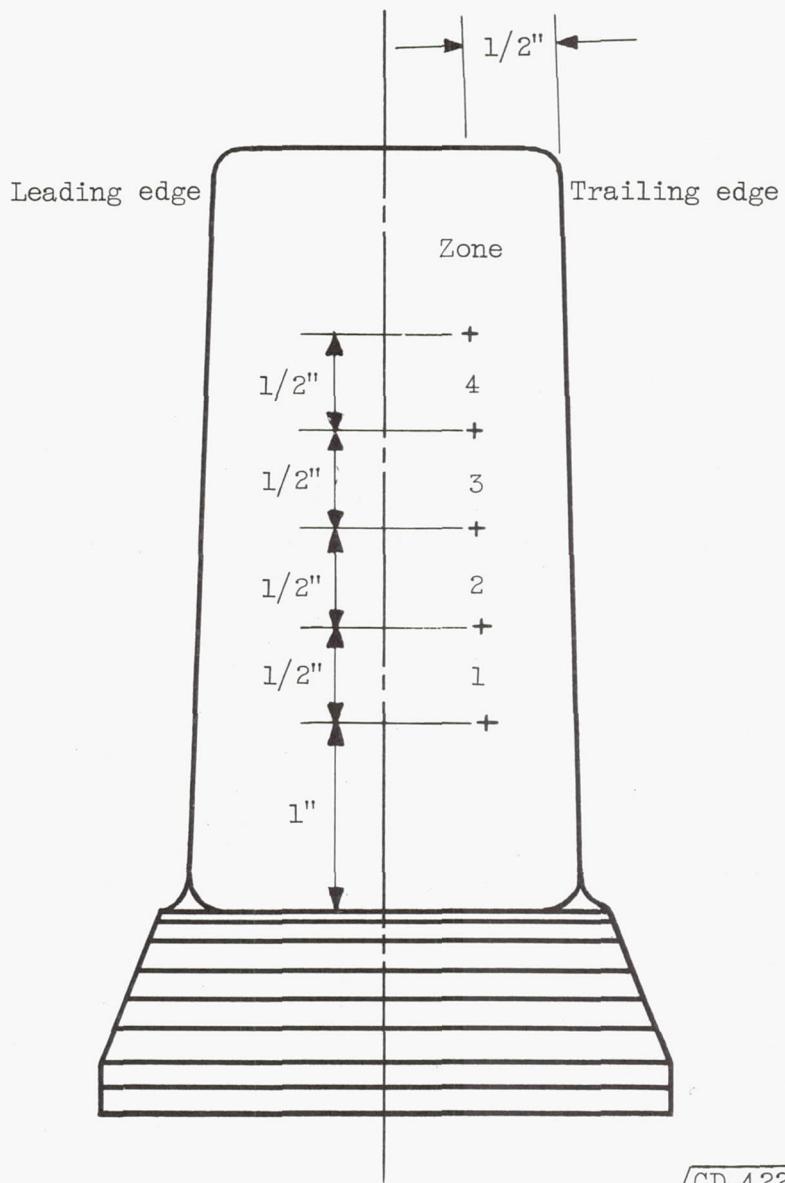
Four buckets were scribed near the trailing edge as shown in figure 3. Bucket elongation measurements were made of the scribe marks after 15 and 60 hours of operation using an optical extensometer.

Figure 3. - Scribed bucket for elongation measurements.

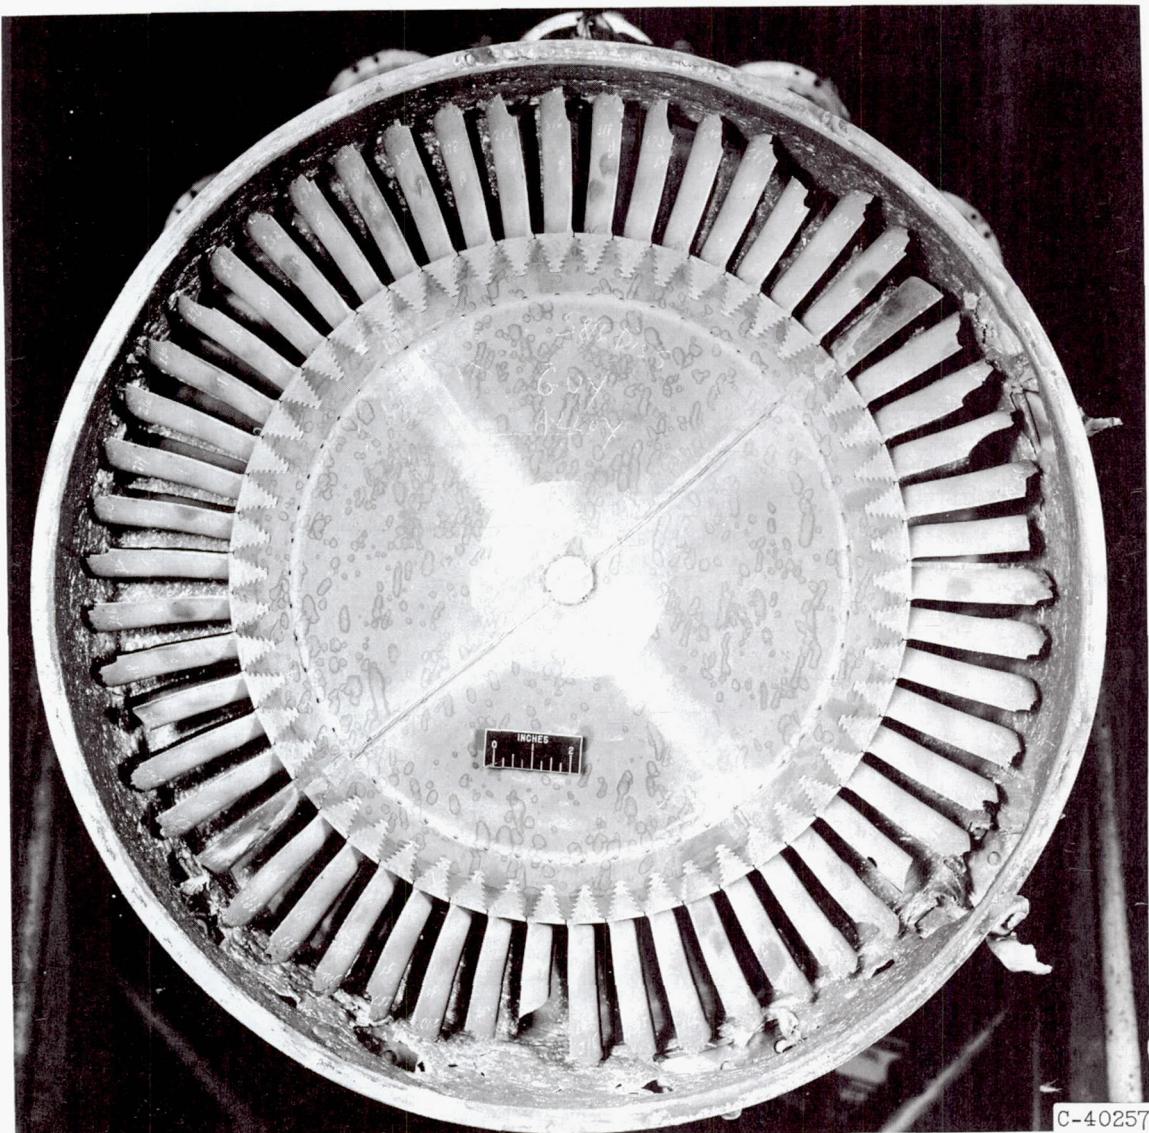
The damaged compressor rotor and housing are illustrated in figure 4(a). Fragments of failed components passed through the combustion section and damaged the buckets as shown in figures 4(b) and (c).

1. Guy alloy buckets were operated successfully for 102 hours at a bucket temperature of 1650° F, indicating that Guy alloy is a potential bucket material for advanced temperatures. The test was terminated at 102 hours by a compressor rotor failure that resulted in extensive damage to the engine and the test buckets.

(a) Compressor housing.  
Figure 4. - Damage to engine.

(b) Turbine; resulting from compressor failure at 102 hours.

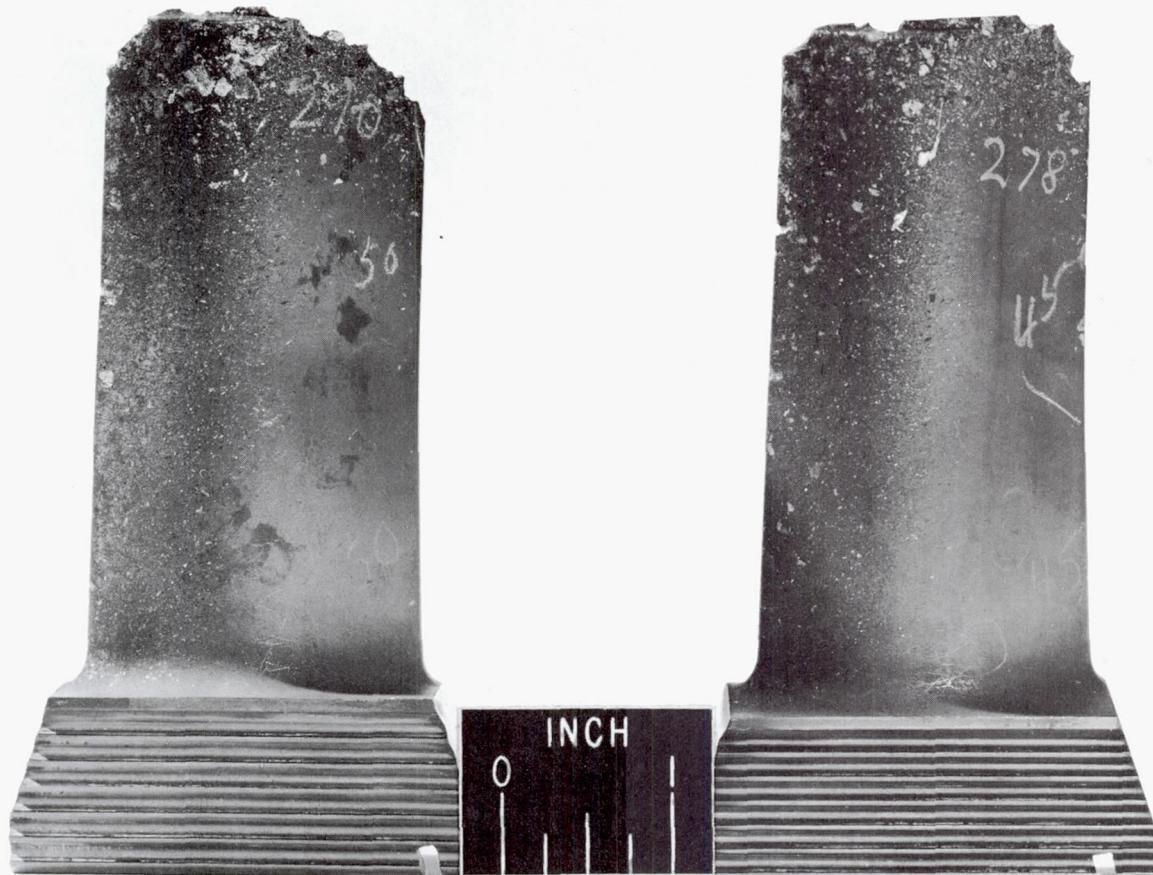
(c) Turbine buckets.

2. While not as ductile as forged materials now in use, Guy alloy appeared to have sufficient ductility to be considered for bucket use. The buckets did not shatter when the compressor failed and a large quantity of material passed through the turbine. Numerous small pieces were chipped off the upper portion of bucket airfoils by impact collisions, but the impact of other fragments was absorbed with no fracture occurring.

Figure 4. - Continued. Damage to engine.

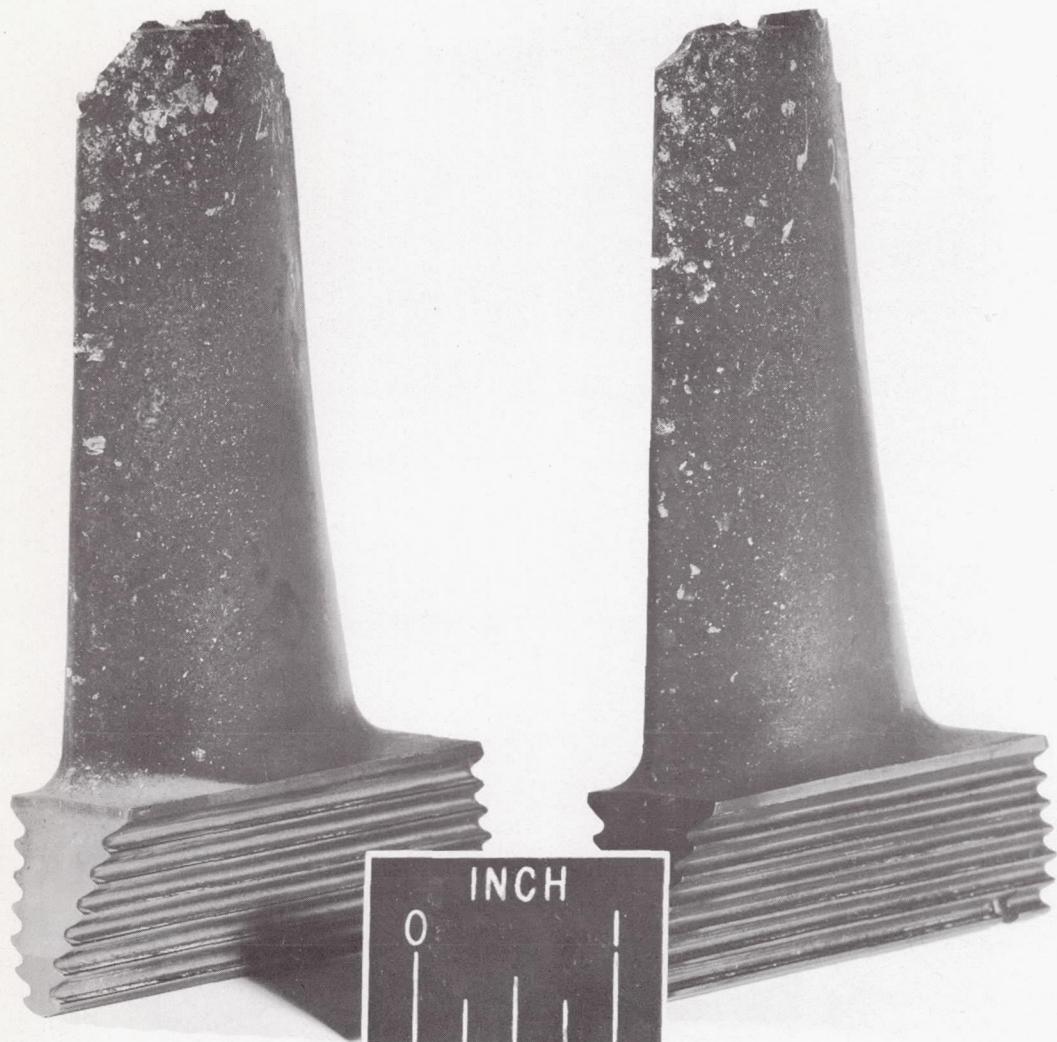
(c) Concluded. Turbine buckets.

Figure 4. - Continued. Damage to engine.

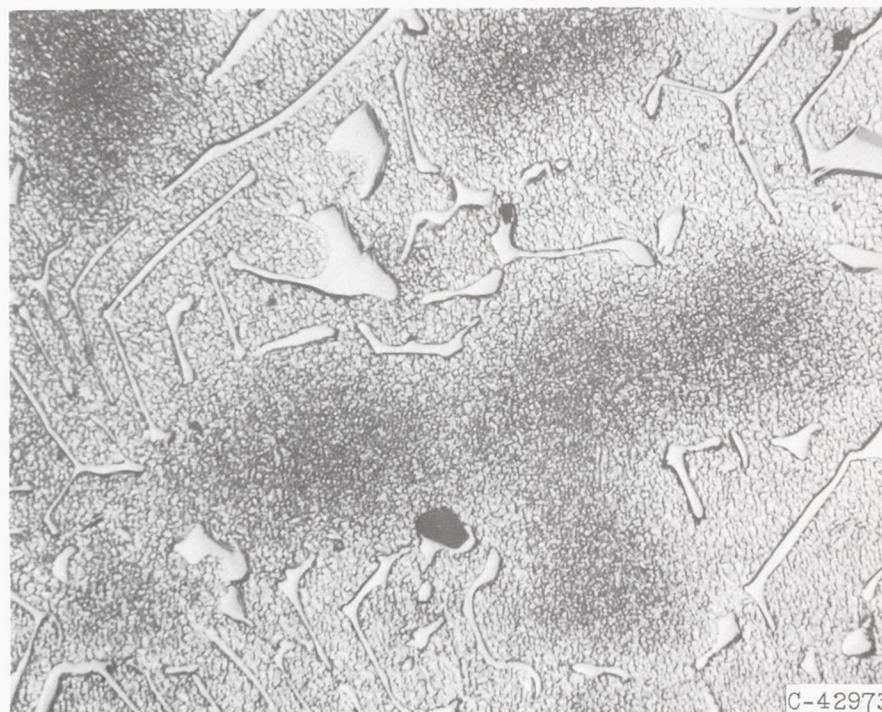
(a) Before engine testing.

Photomicrographs of the typical as-cast structure of Guy alloy buckets are shown in figure 5(a). The photomicrographs in figure 5(b) illustrate the structure after engine testing. Comparison of figure 5(a) with figure 5(b) shows that no visible change occurs as a result of engine testing. Photographs of as-cast macroetched buckets are shown in figure 6. The grain size is small and uniform within each bucket with a small difference in grain size between the two buckets.

Figure 5. - Typical microstructure of Guy alloy. Etchant: 45 percent water; 45 percent glycerol; 10 percent hydroflouric acid.

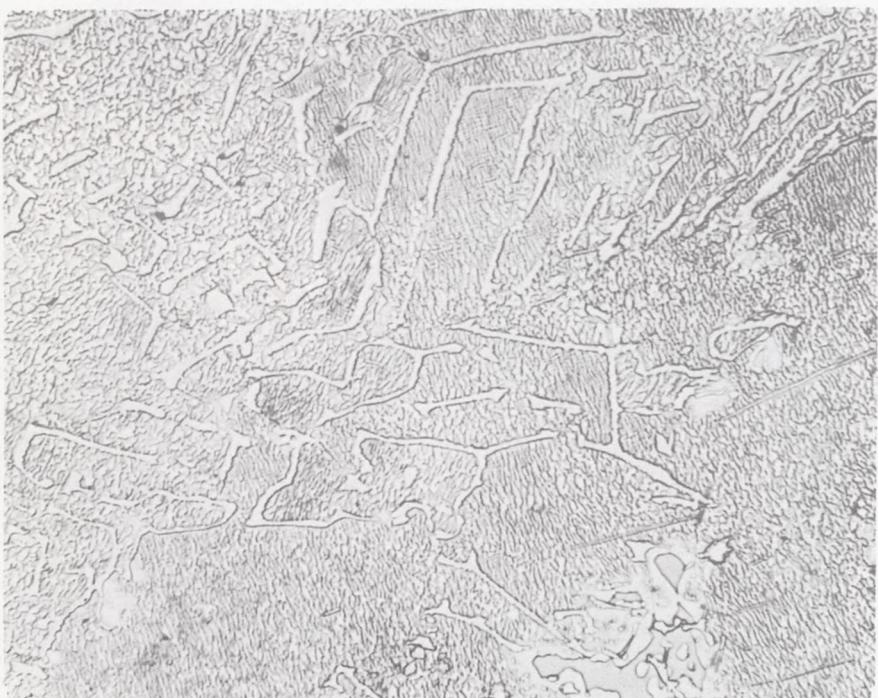
(b) After engine testing.

Figure 5. - Concluded. Typical microstructure of Guy alloy. Etchant: 45 percent water; 45 percent glycerol; 10 percent hydroflouric acid.

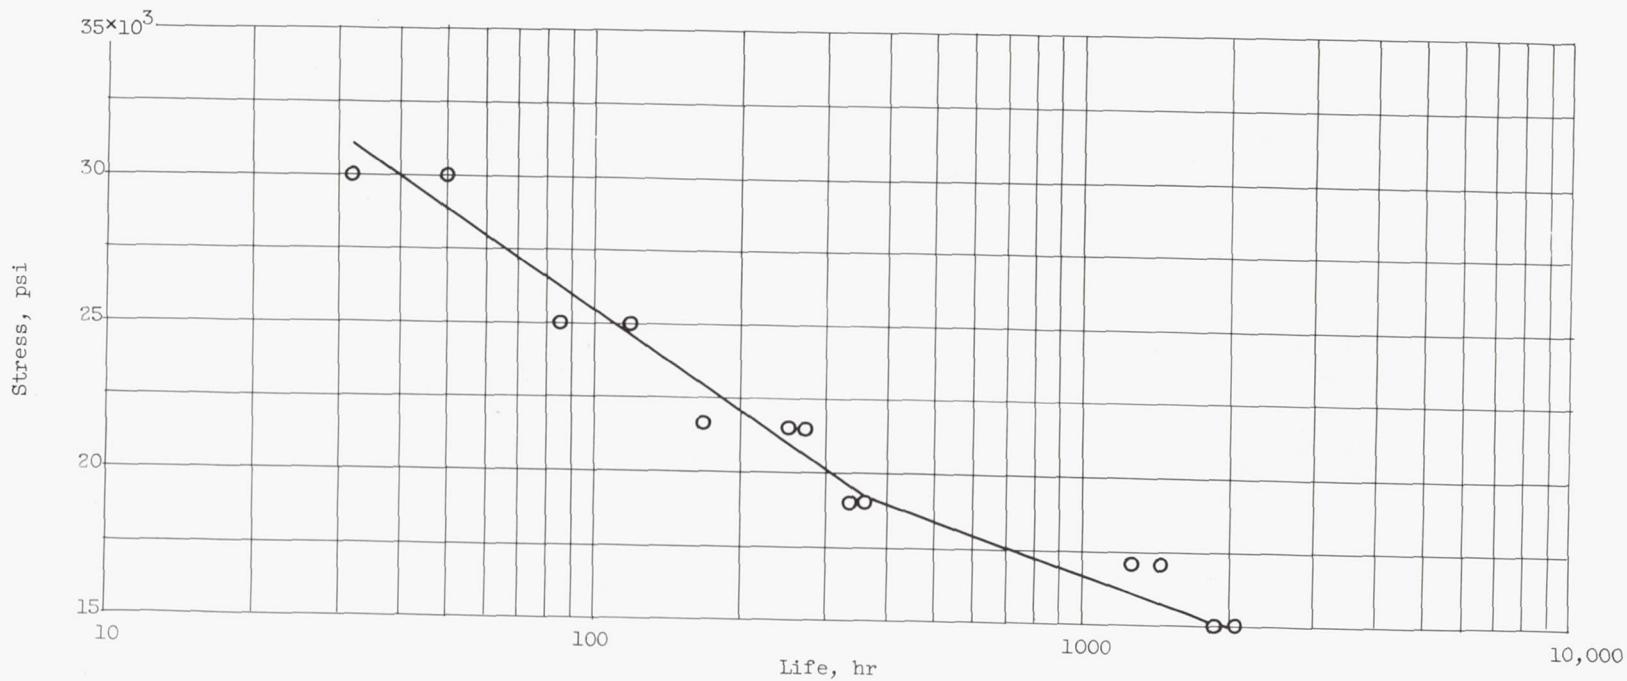
The 1650° F stress-rupture data obtained from as-cast cylindrical test bars are shown in figure 7. The 100-hour stress-rupture strength at 1650° F is 25,500 psi.

Figure 7. - Stress-rupture properties at 1650° F of as-cast test bars obtained from commercial source.

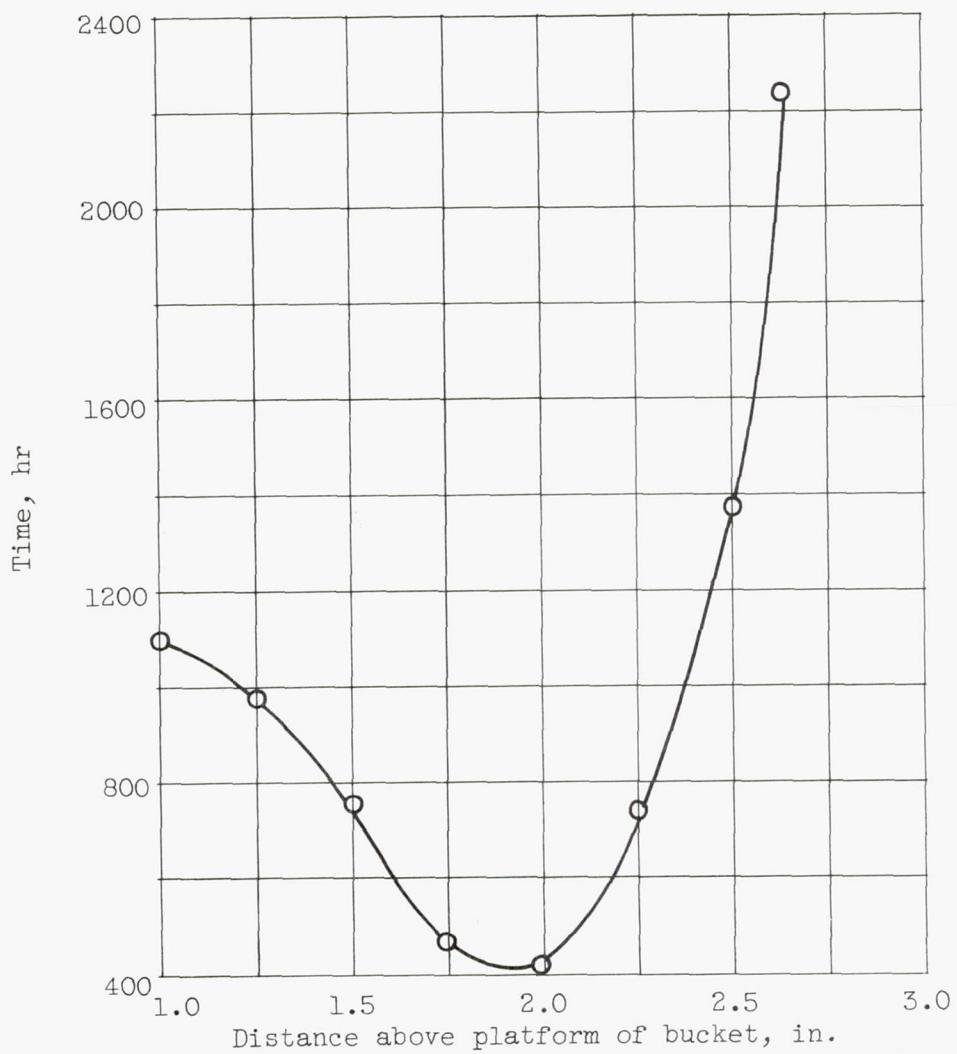
Since the evaluation of Guy alloy buckets was terminated by the compressor failure, it may be of interest to determine what the life of the buckets might have been if they failed by stress rupture. The stress-rupture life of the material at each point along the bucket length can be predicted using the stress and temperature distributions of figure 2 and extrapolating stress-rupture data. A plot of the resulting rupture life against distance above the base of the buckets indicates the location of the minimum life of buckets in stress rupture. This section of the bucket has the most severe combination of centrifugal stress and temperature.

The curve shown in figure 8 is typical of several constructed using mathematical and graphical extrapolation methods. The minimum is the most important section of the curve; this area is obtained from stress-rupture data and is not extrapolated. The rest of the curve should be considered qualitative. If failure results solely from the centrifugal stress and temperature, the buckets should fail about 2 inches above the base and should have an operating life of about 400 hours. In addition to centrifugal stress, it should be remembered that factors such as vibratory stresses, thermal shock, and corrosion may influence blade failures. The influence of these factors usually reduces bucket life below the stress-rupture life.

Figure 8. - Time to rupture at various distances above platform of Guy alloy buckets.
